REPORT #
RRTAC 90-4

Physical and Hydrological Characteristics of Ponds in Reclaimed Upland Landscape Settings and their Impact on Agricultural Capability

PHYSICAL AND HYDROLOGICAL CHARACTERISTICS OF PONDS IN RECLAIMED UPLAND LANDSCAPE SETTINGS AND THEIR IMPACT ON AGRICULTURAL CAPABILITY

Environmental Research and Engineering Department

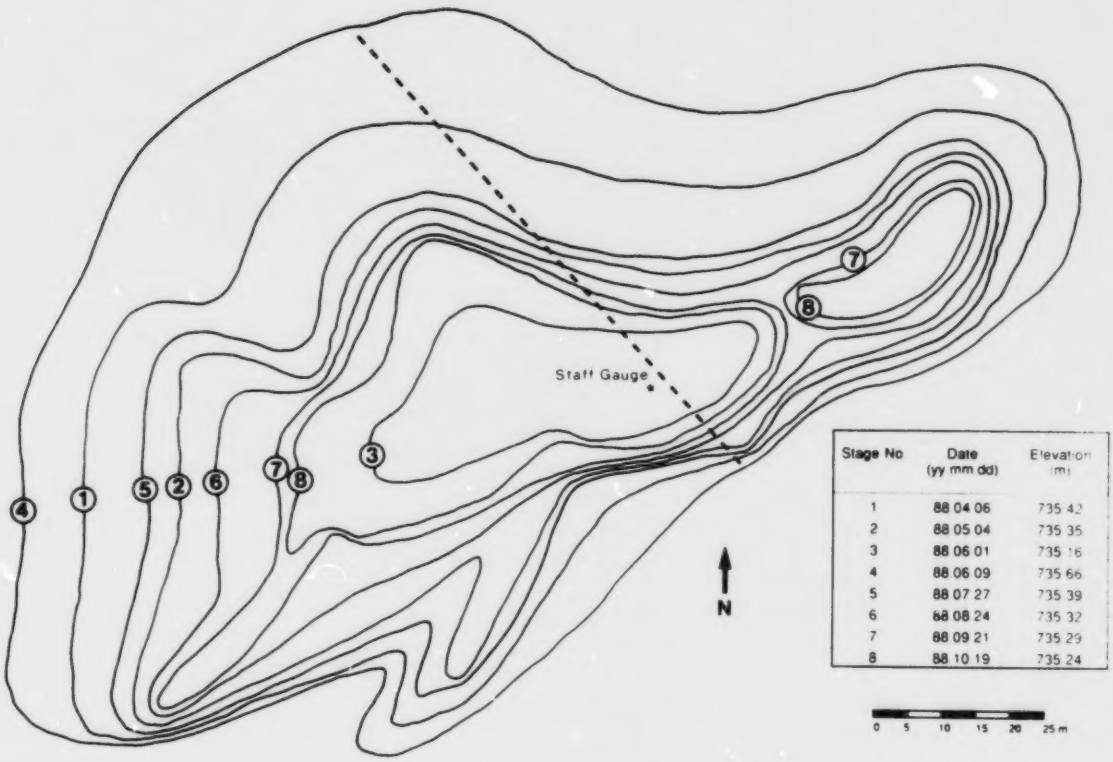
Figure 10. Diagram of pond S195 showing position of shoreline at monitoring events during 1988. The dashed line shows the location of the profile in Figure 14.

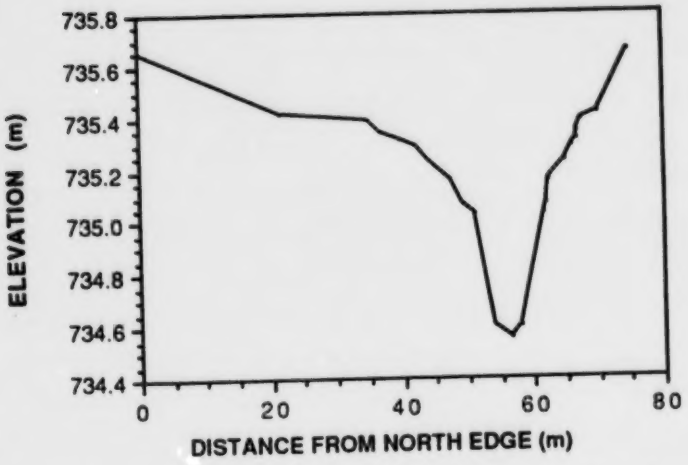
Figure 14. Profile across pond S195 showing broad outer basin and more steep-sided inner subsidence depression. Location of profile is shown by the dashed line in Figure 10.

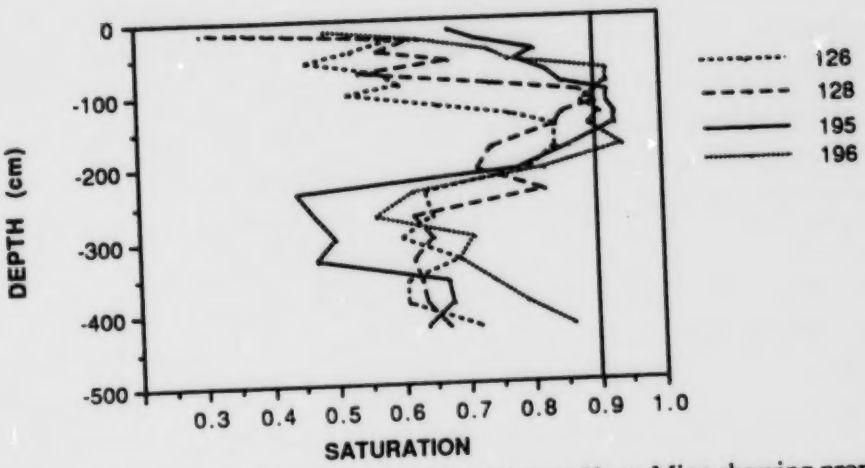
Four sites, BR126, BR128, BR195, and BR196, showed evidence of saturated or near-saturated conditions during 1989 (Figure 16, Table 4). At site BR195, the zone between 105 cm and 150 cm, in the upper part of the spoil, was saturated. At site BR196, the interval

Figure 16. Profiles of nearly saturated upland sites at Vesta Mine showing proportion saturation as a function of depth.

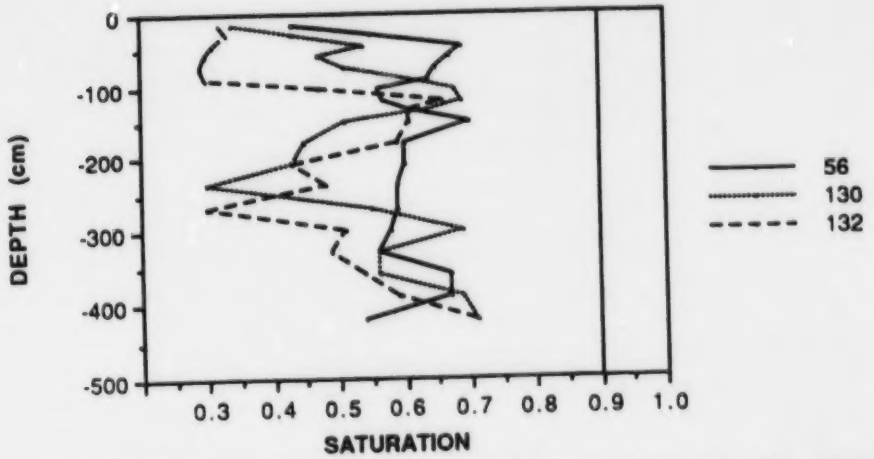
Three sites, BR56, BR130, and BR132, were appreciably drier than the other four sites. Saturation at these dry sites never exceeded 75% of the porosity and was generally considerably lower (Figure 17). Site BR56 is on an elevated knoll. The micro-topography at sites BR130 and BR132 is similar to sites BR126 and BR128. Apparently the drier conditions at the former sites result from the absence of discrete sand layers in the profile.

Figure 17. Profiles of dry upland sites at Vesta Mine showing proportion saturation as a function of depth.

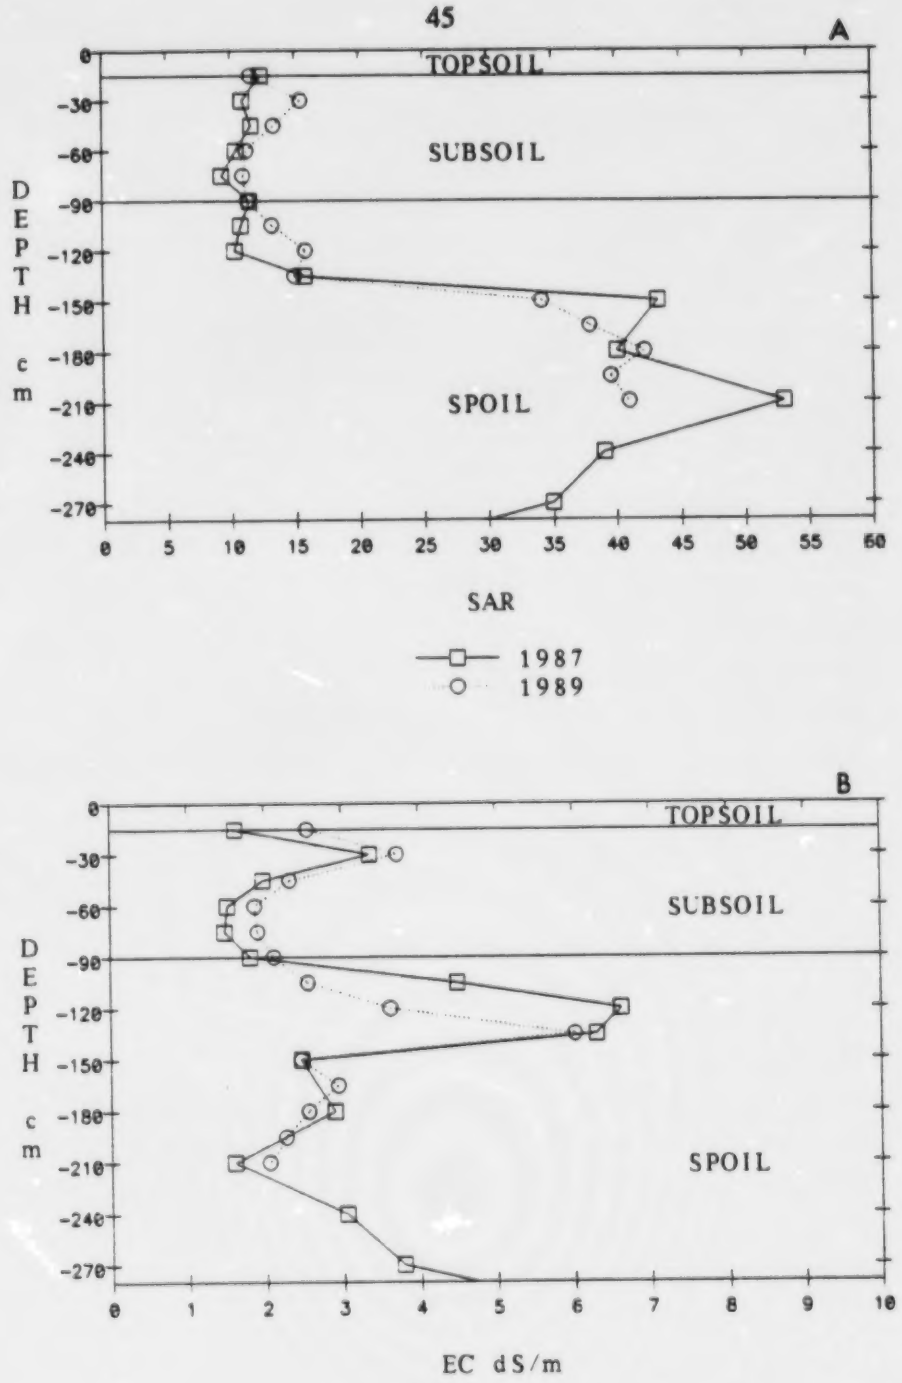
The upper part of the spoil from 105 cm to 180 cm was characterized by slightly higher EC values and lower SAR values than below that depth. Mean EC values ranged from 2.66 dS/m to 5.53 dS/m (Figure 37). Mean SAR values ranged from 13.1 to 18.2 (Figure 37).

Figure 36. A) Sodium Adsorption Ratio (SAR) and B) Electrical Conductivity (EC) as a function of depth, for site BR195 at Vesta Mine. Values are the mean of all determinations each year.

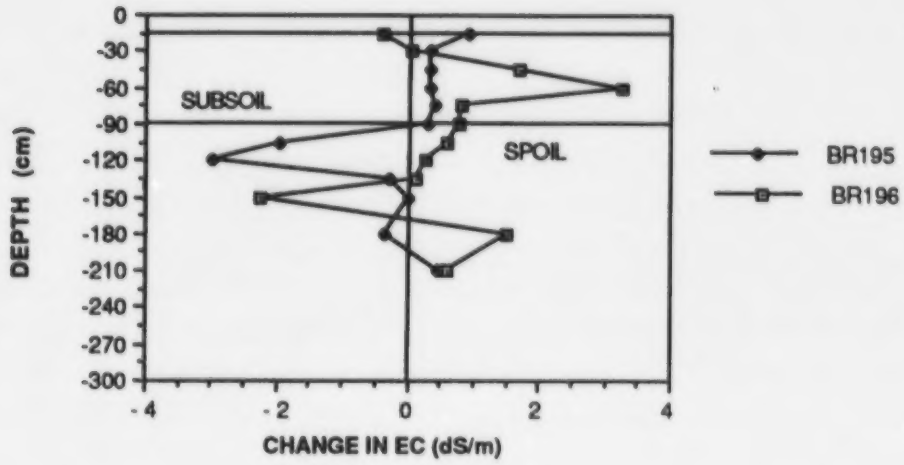
At nest BR195, which is located at the edge of the pond, the increased electrical conductivity (EC) of the topsoil and subsoil combined with the decrease in EC in the upper part of the spoil is indicates upward migration of salt (Figure 36 and 38). The increased SAR in this interval was consistent with this interpretation (Figure 36 and 39). At nest BR196, which is situated about 60 m south of the pond and about 0.40 m higher, the decrease in EC of the topsoil and marked increase in the subsoil reflects leaching at the top of the profile and accumulation at greater depth in the profile (Figure 37 and 39).

Figure 38. Depth profiles showing change in electrical conductivity (EC) between 1987 and 1989 at sites BR195 and BR196.

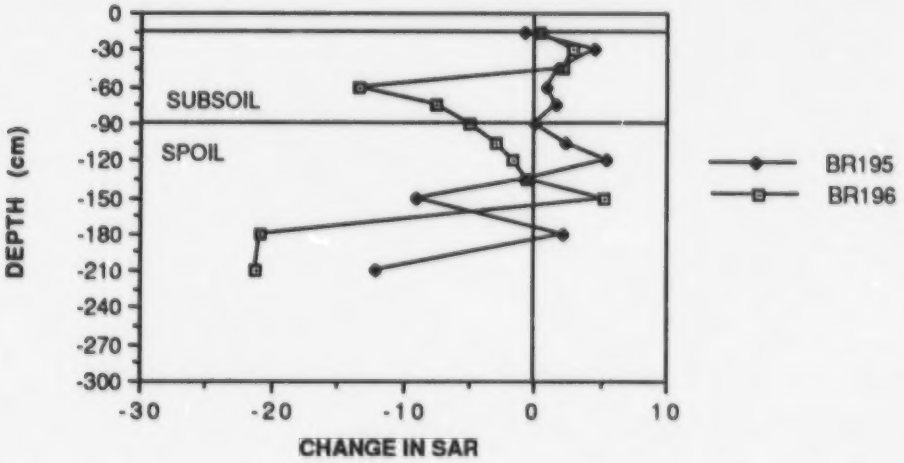
Figure 39. Depth profiles showing change in sodium adsorption ratio (SAR) between 1987 and 1989 at sites BR195 and BR196.

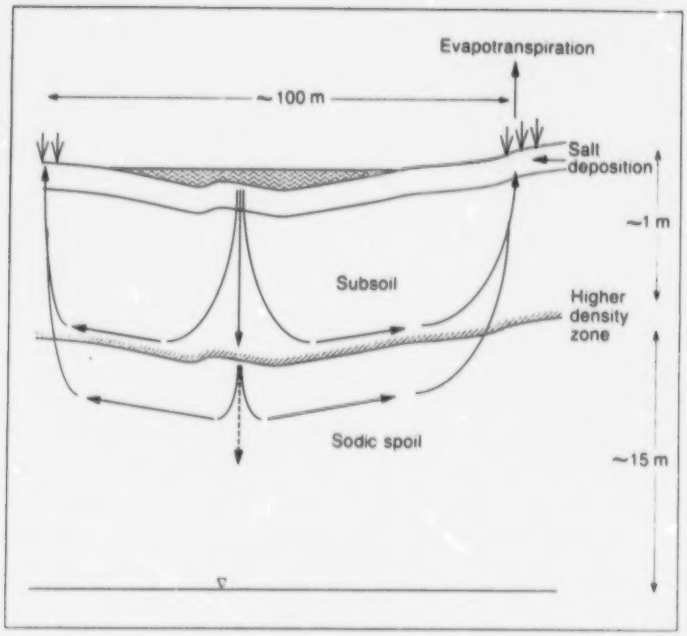
A potentially important negative impact of perched ponds is the development of saline sodic soil conditions in the fringe area around the pond. Small white salt patches were observed on the soil at various places around pond S195 in May, 1988 (Figure 44). Unlike lowland reclaimed areas, where the saline areas are the same from one year to the next, the location and intensity of the salinity at this upland site varies from year to year. Because pond S195 is ephemeral, its margins fluctuate over a considerable distance during the year. In addition, the land surface is continuing to subside and as a result the configuration of the depression changes from year to year. It is expected however, that once the subsidence ceases, the pond will become much more stable from year to year and the concentration of salt will be localized in the same area and therefore is expected to increase in severity with time.

The saline fringe results from radial outward flow from the pond itself. The upper surface of the sodic spoil acts as a barrier to rapid infiltration and forces lateral flow from beneath the pond outward toward discharge areas in the fringe area (Figure 45). The severity of salinity in this setting is not expected to be as great as in lowland settings because the total amount of salt available in upland settings is limited to the amount of salt in the subsoil beneath the pond; in lowland settings, salt is contributed from beneath the neighboring uplands as well. In addition to this, perched ponds are groundwater recharge sites in which the tendency is for salt to be redissolved from the saline fringe and carried downward. The initial precipitation of salt results only because the rate of recharge is much slower than the rate at which water is supplied to the pond. In upland settings, where sodic spoil is encountered at depths of 1.0 m to 1.5 m beneath the surface, the salinity problem is expected to be exacerbated by sodium salts that are carried upward from the spoil and precipitated in the saline fringe around pond margins.

Figure 45. Schematic drawing showing formation of saline and sodic conditions in soil bordering a perched pond such as S195 as a result of lateral groundwater flow induced by a barrier in the top of the spoil.
